**Flood Control Project Maintenance
Levee Inspections**

Fall 2019 Levee Maintenance Deficiency Summary Report

**Flood Control Project Maintenance
Levee Inspections****LMA District Cover Sheet****Fall 2019 Levee Inspection Results****Sacramento River West Side Levee District**

Sacramento River West Side Levee District

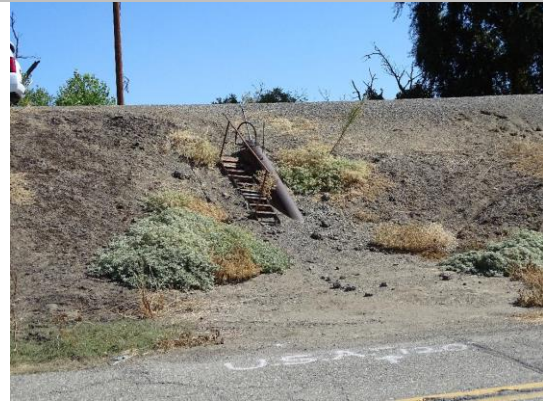
Photo 3 of 3 : UCIP_FA_2019_56074_83210.jpg

Item	DRAFT DWR UCIP Field Study			39.025637 °	39.025637 °	
				-121.823450 °	-121.823450 °	
DWR ID	20397					
Comment Code						
Inspector Comment						
DS_ID:20397 FS_ID:56074 EP_NO: 9371 Repair Type: Non-Urgent Crossing Status: Found UCIP Comments: 10/01/2019 Record changed from No Action Needed to Non-Urgent. Need to have CVFPB review ABO and determine current owner. (O.Yakimov - DWR UCIP) FIELD_STRUCT_DESC: 2 of 2: 14-inch steel irrigation pipe through the levee, 5 feet below the crown. Slant pump on a steel structure on the waterside (WS) bank. 4-foot diameter concrete standpipe on the landside (LS) toe with a butterfly valve at the west side of Highway 45. Hand pump on pipe at the LS shoulder. (two 14-inch pipes, at different depths, authorized under Automatic Board Order (ABO) issued as Permit No. 9371, 1974 - Fred, Lloyd, and Beverly Durst). [Additional Reference(s): DWR Levee Log, 2006. USACE Sacramento O&M Manual 131, May 1960 (HLM 26.92), one 14-inch pipe referenced]. FS Date: 10/1/2019 3:18:00 PM

LS levee slope

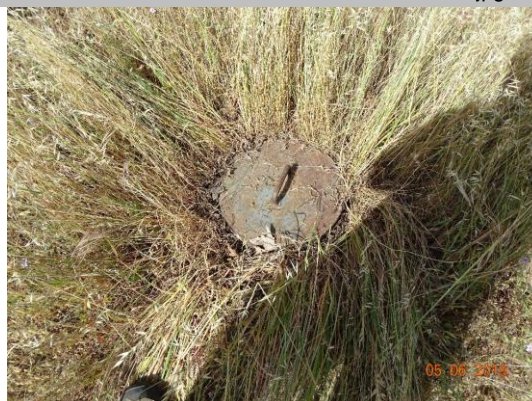
Photo 1 of 3 : UCIP_FA_2019_53978_79198.jpg

Comment Code					
Inspector Comment					
DS_ID:20255					
FS_ID:53978					
EP_NO: 4786					
Repair Type: Non-Urgent					
Crossing Status: Found					
UCIP Comments: 05/06/2019 Crossing not in use and looks abandoned. Air release valve is silted inside a riser on WS shoulder (O.Yakimov - DWR UCIP)					
FIELD_STRUCT_DESC: 16-inch steel drainage pipe through the levee, 6.2 feet below the crown. One metal cutoff wall. Gate valve on the landside (LS) end. Siphon breaker on the waterside (WS) slope inside steel riser unit. Flap gate on the WS end. Bank rock revetted. (Permit No. 4786, 1964 - F. Erdman). [Additional Reference(s): DWR Levee Log, 2006].					
FS Date: 5/6/2019 4:11:08 PM

View of covered metal riser on WS shoulder

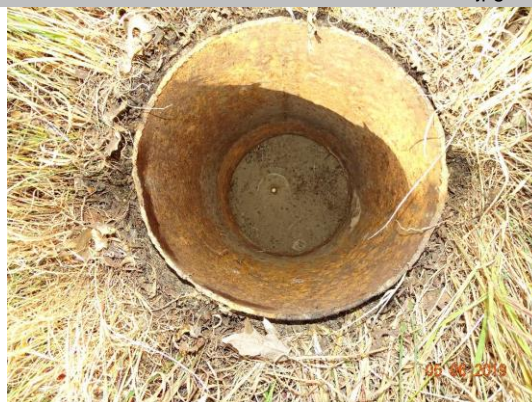
Photo 2 of 3 : UCIP_FA_2019_53978_79199.jpg

LM Start	26.83	Rating **	M	Issue No.	1617 (cont)
LM End	26.83	Issue Type +	En	Location *

Air valve is silted inside of metal riser

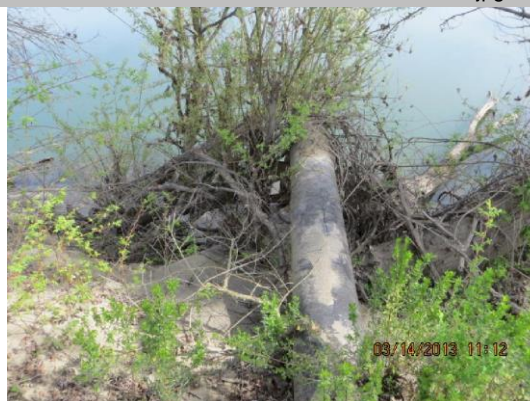
Photo 3 of 3 : UCIP_FA_2019_53978_17539.jpg

Pipe at rivers edge.

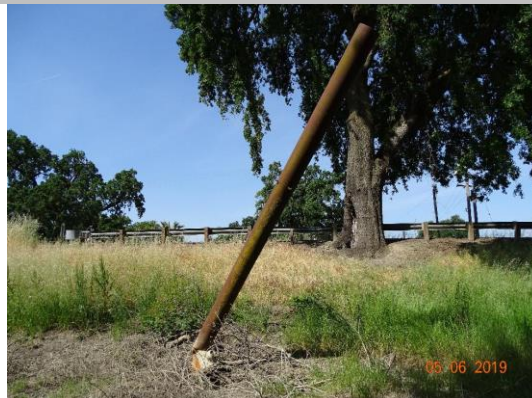
Photo 1 of 3 : UCIP_FA_2019_53980_79202.jpg

Comment Code						
Inspector Comment						
DS_ID:20256 FS_ID:53980 EP_NO: 9368 Repair Type: Urgent Crossing Status: Found UCIP Comments: 05/06/2019 Standpipe on WS slope is damaged. A tree that was located next to the stand pipe is gone. At the place of former tree roots there is a large pit hole 3x4x2 feet starting from WS levee toe going into WS slope. Missing operation wheel on gate valve off LS toe. Crossing is abandoned and needs a proper abandonment or removal. (O.Yakimov - DWR UCIP) Need to abandon pipe properly. FIELD_STRUCT_DESC: 24-inch steel irrigation pipe through the levee, 16.2 feet below the crown. Pump on the waterside (WS) bank. Gate valve on the landside (LS) end. Concrete box at the LS toe of the slope. Irrigation well 6 feet from the toe of the landward slope. (Automatic Board Order (ABO) issued as Permit No. 9368, 1974 - Fredinand Erdman). [Additional Reference(s): DWR Levee Log, 2006. USACE Sacramento O&M Manual 131, May 1960 (HLM 27.79) (standpipe on the WS)]. FS Date: 5/6/2019 8:19:13 AM

LM Start	27.46	Rating **	U	Issue No.	1618 (cont)
LM End	27.46	Issue Type +	En	Location *

Bent metal standpipe at WS toe

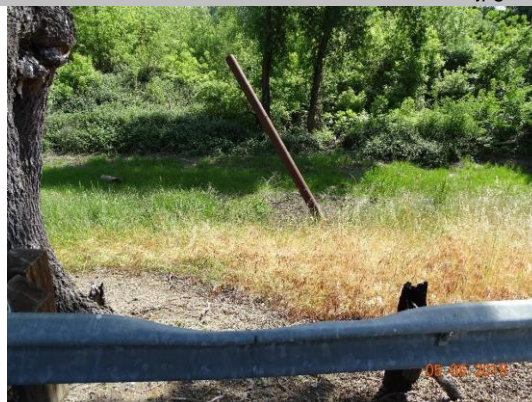
Photo 2 of 3 : UCIP_FA_2019_53980_79206.jpg

View of bent metal standpipe at WS toe

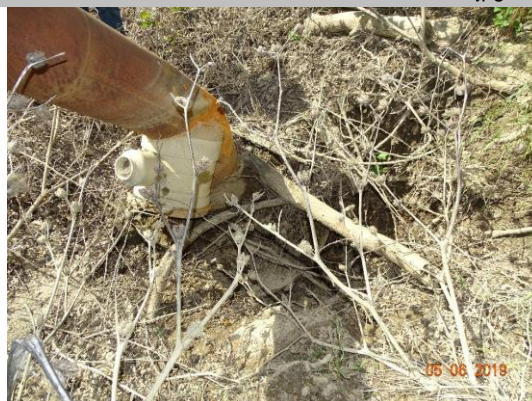
Photo 3 of 3 : UCIP_FA_2019_53980_79203.jpg

Damaged standpipe

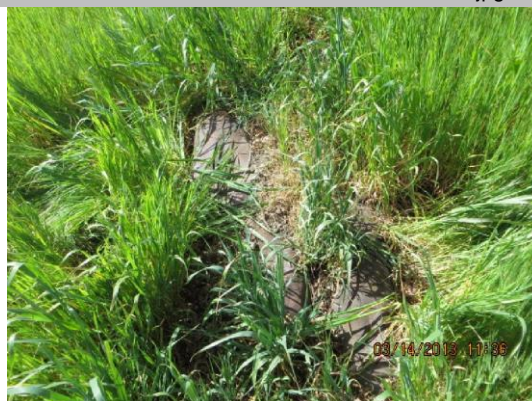
Photo 1 of 2 : UCIP_FA_2019_53981_17545.jpg

Comment Code						
Inspector Comment						
DS_ID:20416						
FS_ID:53981						
EP_NO: N/A						
Repair Type: Non-Urgent						
Crossing Status: Indicator Found						
UCIP Comments: 05/06/2019 Crossing not found. A candidate for electromagnetic survey.(O.Yakimov - DWR UCIP)						
Appears this pipe is abandoned and visible on WS slope in pieces.						
Need to verify proper abandonment.						
FIELD_STRUCT_DESC: *ABANDONED* 24-inch pipe of an unknown type and material through the levee, 6.2 feet below the crown. Pipe debris on the waterside (WS) slope. [Additional Reference(s): USACE Sacramento O&M Manual 131, May 1960 (HLM 27.79)].						
FS Date: 5/6/2019 9:13:36 AM

Pipe debris on WS slope.

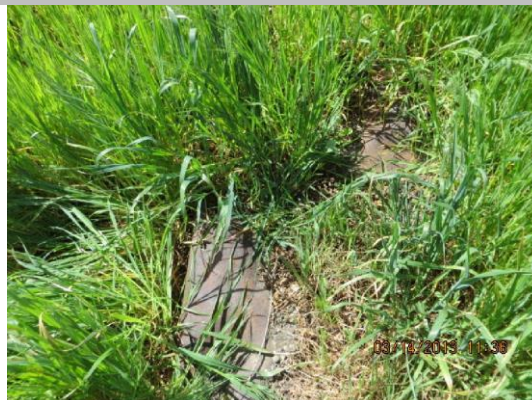
Photo 2 of 2 : UCIP_FA_2019_53981_17544.jpg

Pipe debris on WS slope.

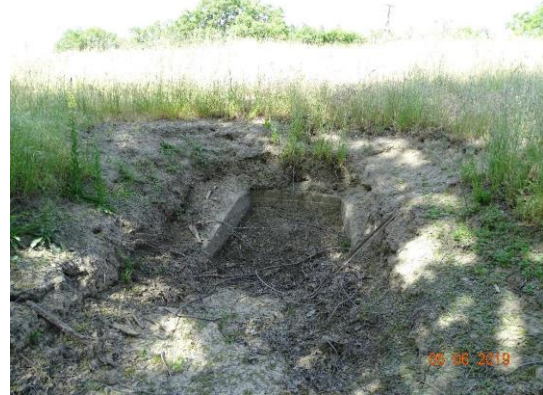
Photo 1 of 3 : UCIP_FA_2019_53982_79209.jpg

Comment Code						
Inspector Comment						
DS_ID:20257 FS_ID:53982 EP_NO: 9355 Repair Type: Non-Urgent Crossing Status: Found UCIP Comments: 05/06/2019 Inlet and outlet gates are silted. Missing handwheel on gate valve at LS toe. (O.Yakimov - DWR UCIP) Pipe needs to be properly abandoned. FIELD_STRUCT_DESC: *ABANDONED* 24-inch steel drainage pipe through the levee, 14 feet below the crown. Slide gate on the waterside (WS) end. Gate valve on the landside (LS) end. (24-inch pipe [HLM 27.89] authorized under Automatic Board Order (ABO) issued as Permit No. 9355, 1974 - Alvin Gustafson). [Additional Reference(s): DWR Levee Log, 2006. USACE Sacramento O&M Manual 131, May 1960 (HLM 27.89)]. FS Date: 5/6/2019 9:24:06 AM

LM Start	27.54	Rating **	M	Issue No.	1620 (cont)
LM End	27.54	Issue Type +	Ma	Location *

Slide gate silted on WS end

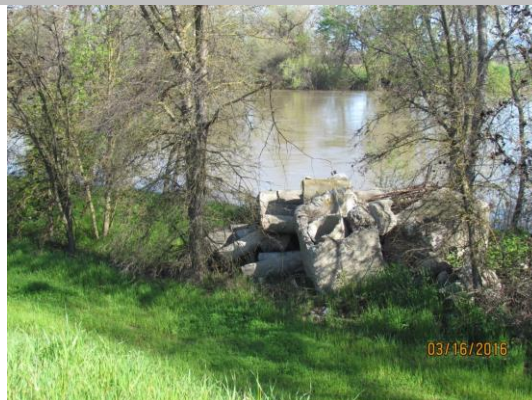
Photo 1 of 1 : FA_2019_NA0016_435_59_20190829_00018.jpg

LM Start	28.02	Rating **	M	Issue No.	59
LM End	28.02	Issue Type +	En	Location *	WS
Category	Earthen Levee			GPS Latitude/Longitude	
				Start	End
Item	Encroachments			39.040750 °	39.040750 °
				-121.835299 °	-121.835299 °
DWR ID	DWR_NA0016_01_s_2012_59				
Comment Code					
DE : Debris					
Inspector Comment					
There are piles of concrete on the waterside berm.

View of the pile of concrete on the waterward berm of the levee. Spring 2016.

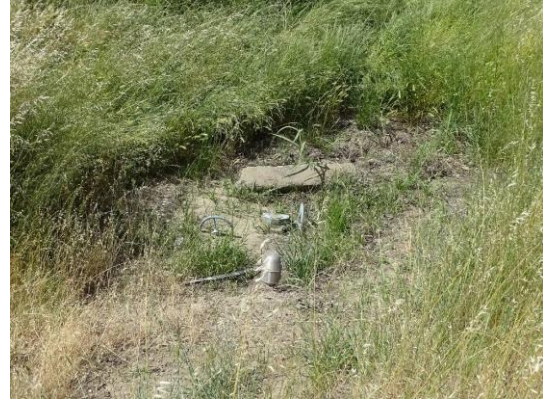
Photo 1 of 3 : UCIP_FA_2019_53983_79212.jpg

Comment Code					
Inspector Comment					
DS_ID:20258 FS_ID:53983 EP_NO: 9367 Repair Type: Non-Urgent Crossing Status: Found UCIP Comments: 05/06/2019 Closure devices located at LS toe are buried with mud that limits their operation. (O.Yakimov - DWR UCIP) FIELD_STRUCT_DESC: 14-inch irrigation pipe of an unknown material through the levee, 7.5 feet below the crown. Pump in pump house on the waterside (WS) bank. Siphon breaker inside a 24-inch corrugated metal riser unit on the landside (LS) slope. Pole on the WS shoulder. (Automatic Board Order (ABO) issued as Permit No. 9367, 1974 - Elna Schohr, Inc.). [Additional Reference(s): DWR Levee Log, 2006. USACE Sacramento O&M Manual 131, May 1960 (HLM 28.41)]. FS Date: 5/6/2019 11:22:51 AM

Closure devices at LS toe

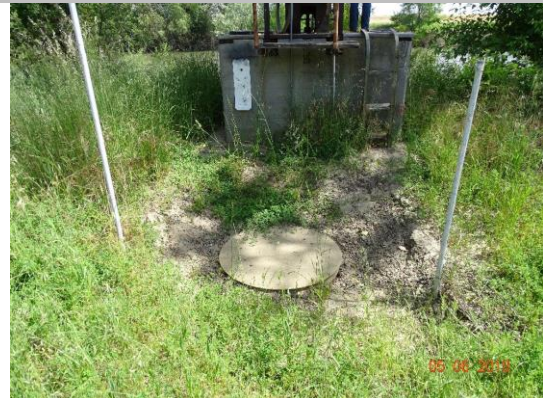
Photo 2 of 3 : UCIP_FA_2019_53983_79213.jpg

Pumping vault at riverbank

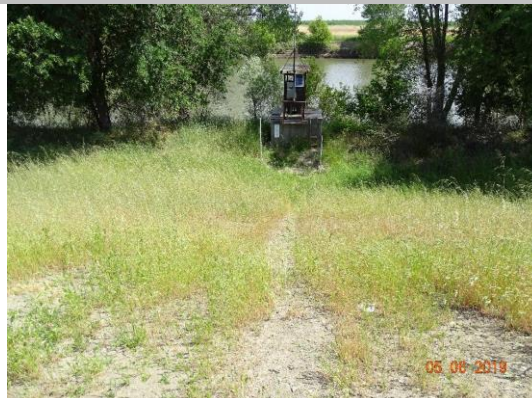
Photo 3 of 3 : UCIP_FA_2019_53983_79215.jpg

View of pump on WS berm

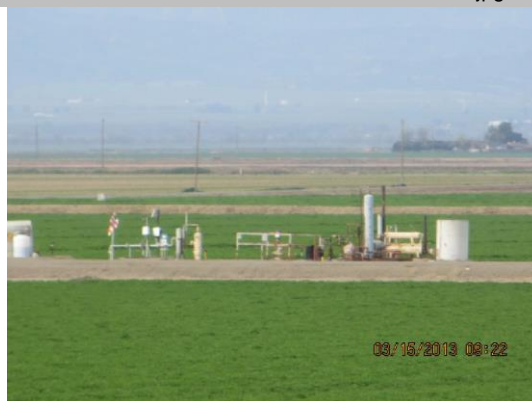
Photo 1 of 1 : UCIP_FA_2019_53984_17563.jpg

Comment Code						
Inspector Comment						
DS_ID:20319 FS_ID:53984 EP_NO: 16632 Repair Type: Non-Urgent Crossing Status: Indicator Found UCIP Comments: 05/06/2019 No gas line markers observed. (O.Yakimov - DWR UCIP)09/01/2016 - No markers on levee. no condition in permit for markers. Pipe is well underneath the levee prism with minimum clearance under the river of 35 feet per permit drawings. (T. Hatch/UCIP) 03/15/2013 No gasline markers on either side of levee. (W. Wylie/UCIP) FIELD_STRUCT_DESC: 4-inch welded steel natural gas pipeline through the levee, 62 feet below the crown. Crosses under both levees and the Sacramento River channel with a minimum clearance of 35 feet. Gas well visible approximately 1,500 feet west of the levee on the landside (LS). (Permit No. 16632, 1997 - Slawson Exploration Company, Inc./AA Production Services, Inc.). FS Date: 5/6/2019 12:47:47 PM

gas well 1500-feet west of this location.

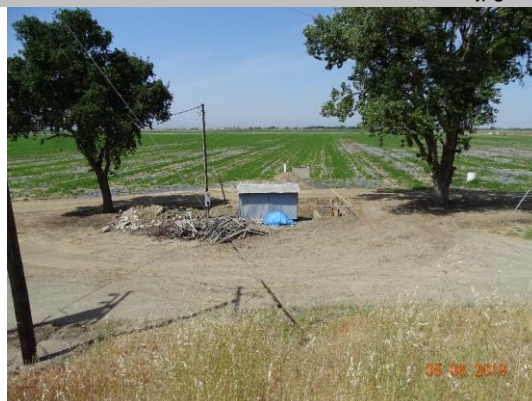
Photo 1 of 3 : UCIP_FA_2019_53985_79218.jpg

Pumphouse and sump on LS looking from levee crown

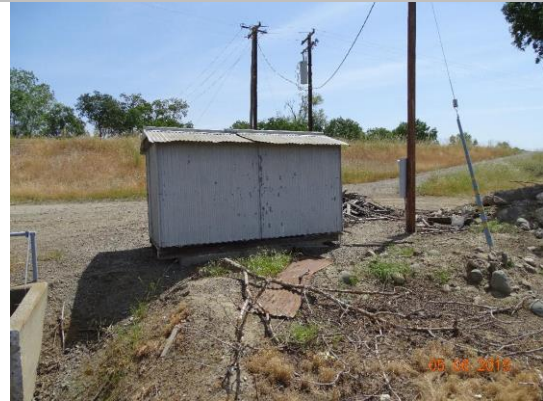
Photo 3 of 3 : UCIP_FA_2019_53985_79219.jpg

Pumphouse and sump on LS looking from landside

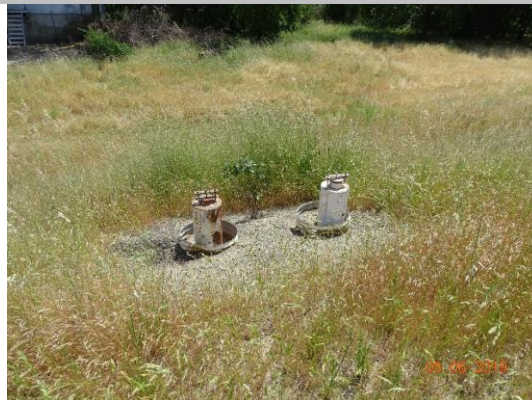
Photo 1 of 3 : UCIP_FA_2019_53986_79220.jpg

CMP riser with siphon breaker on WS slope

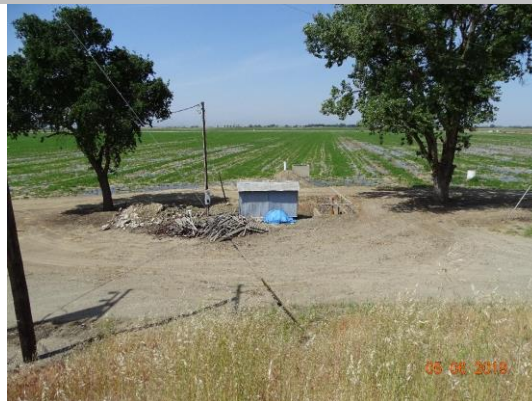
Photo 2 of 3 : UCIP_FA_2019_53986_79221.jpg

Pumphouse and sump on LS looking from levee crown

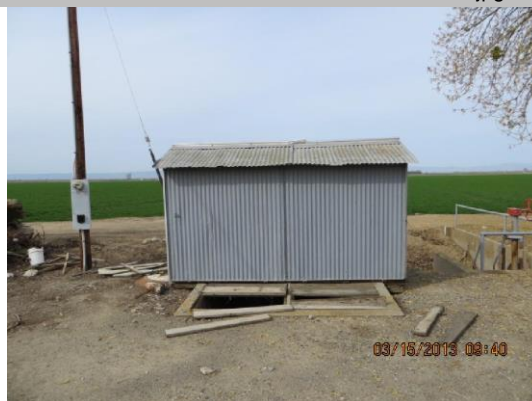
Photo 3 of 3 : UCIP_FA_2019_53986_17569.jpg

Pumphouse over sump on LS toe.

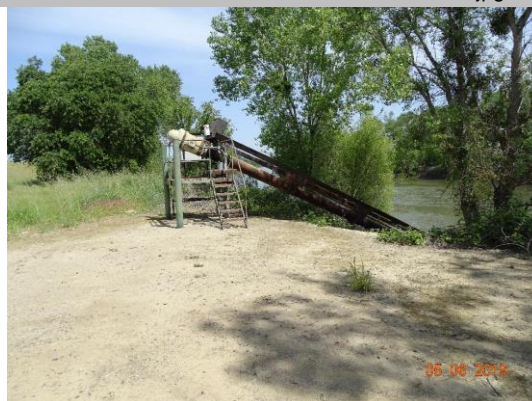
Photo 1 of 3 : UCIP_FA_2019_53987_79225.jpg

Comment Code					
Inspector Comment					
DS_ID:20340 FS_ID:53987 EP_NO: 9358 Repair Type: Non-Urgent Crossing Status: Found UCIP Comments: 05/06/2019 No issues recorded during inspection. Observed pipe running - no leaks. (O.Yakimov - DWR UCIP) FIELD_STRUCT_DESC: 24-inch steel irrigation pipe through the levee, 24.5 feet below the crown. Screw gate in pump house on the waterside (WS) berm. 24-inch corrugated metal riser unit on the WS berm where slant pump on steel structure at water's edge ties into this pipe (butterfly valve at junction). Butterfly valve in concrete sump at landside (LS) toe. Overhead power line crosses the levee. Pole on the LS shoulder. (one 12-inch, one 16-inch, and one 24-inch pipes [HLM 29.02] authorized under Automatic Board Order (ABO) issued as Permit No. 9358, 1974 - Crocker National Bank (Trustee)). [Additional Reference(s): USACE Sacramento O&M Manual 131, May 1960 (HLM 29.02)]. FS Date: 5/6/2019 2:38:58 PM

View of slant pump on WS berm

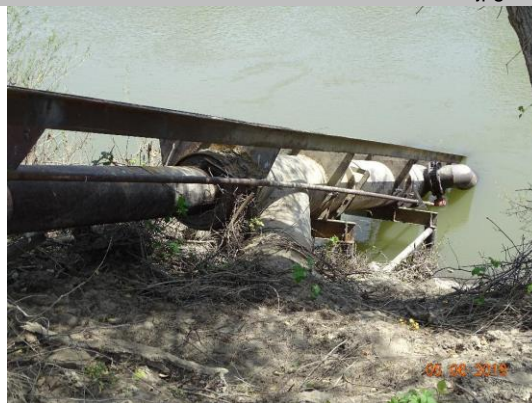
Photo 2 of 3 : UCIP_FA_2019_53987_79227.jpg

Intake pipe at riverbank

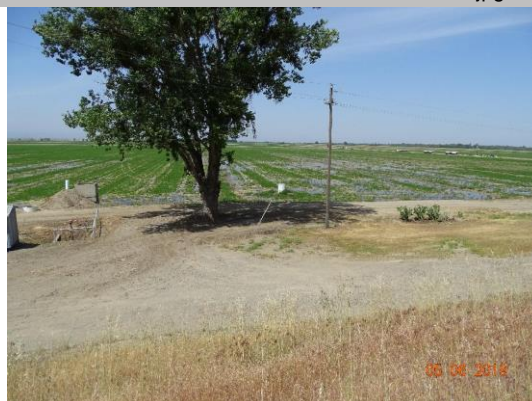
Photo 3 of 3 : UCIP_FA_2019_53987_79226.jpg

View of appurtenances on LS looking from levee crown

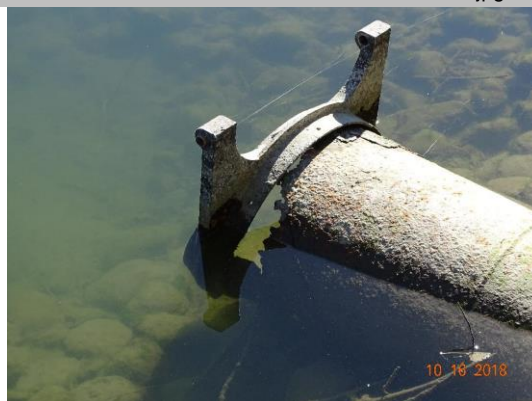
Photo 1 of 3 : UCIP_FA_2019_53988_78171.jpg

DS_ID:20311
FS_ID:53988
EP_NO: 12609
Repair Type: Urgent
Crossing Status: Found
UCIP Comments: 05/06/2019 No changes from last inspection. Pipe on riverbank is under water. (O.Yakimov - DWR UCIP)10/16/2018 Water level is low enough to see that flap gate on WS end is missing. In addition, pipe has corroded through around flap gate frame. Unable to locate pipe inlet on LS. Crossing should be abandoned properly. Recommend internal pipe inspection to determine pipe integrity through levee. (O.Yakimov - DWR)09/23/2016 - pipe outlet still submerged, but visible enough to determine that flap gate is still missing. Appurtenances on the LS of the levee do not appear to be associated with this pipe. There is no visible location for collection of drainage water to go through the outfall. As a result, it does not appear that this pipe is in use. (T. Hatch/UCIP) 09/01/201 - pipe outlet was submerged at time of inspection. Unable to view if flap gate had been replaced. Otherwise, conditions do not appear to be significantly different from previous inspection. (T. Hatch/UCIP) 03/15/201- Flap gate missing from waterward end of pipe. (W. Wylie/UCIP)

FIELD_STRUCT_DESC: 24-inch steel outfall drainage pipe through the levee, 4.1 feet below the crown. Siphon breaker inside an 18-inch concrete riser unit on the waterside (WS) shoulder. Flap gate on the WS toe. Rock protection along the riverbank at the WS toe. (Permit No. 12609, 1978 - Jack E. Gross). [Additional Reference(s): DWR Levee Log, 2006].
FS Date: 5/6/2019 3:02:33 PM

Missing flap gate on WS end. Pipe is corroded through.

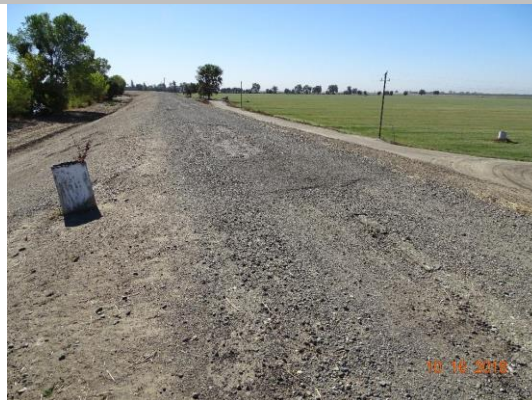
Photo 2 of 3 : UCIP_FA_2019_53988_78168.jpg

View of levee crown at crossing.

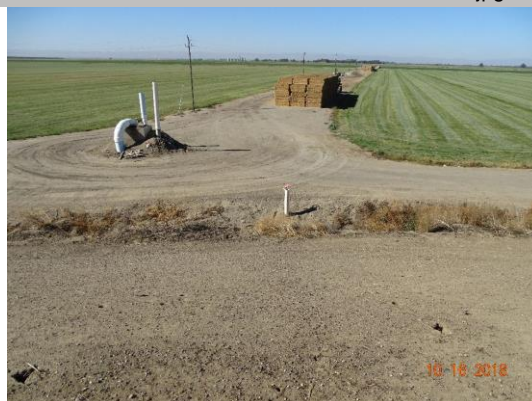
Photo 3 of 3 : UCIP_FA_2019_53988_78169.jpg

Pipe is not found on LS. Appurtenances on LS are not associated with this crossing.

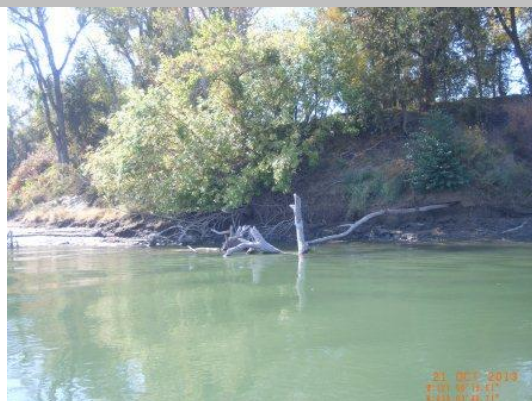
Photo 1 of 1 : FA_2019_NA0016_435_89_20190829_00027.jpg

LM Start	29.69	Rating **	A/W	Issue No.	89
LM End	29.73	Issue Type +	Ma	Location *	WS
Category	Supplemental			GPS Latitude/Longitude	
				Start	End
Item	2017 USACE Erosion Survey			39.063209 °	39.063997 °
				-121.838927 °	-121.839335 °
DWR ID	DWR_NA0016_01_f _ 2018_89				
Comment Code					
Inspector Comment					
2017 Site ID: SAC 122.0 R					
Status: Eroding					
2017 Field Notes: Minor new erosion at toe.					
Site History: 1997 - Mass failure of the lower cohesive bank and toe.					
2000 - Still eroding, steeply dipping foresets in the toe are falling off.					
2010 - Some new erosion and some new deposition. Eddy current off					
the upstream rock. 2011 - Still plenty of berm left. 2016 - Minor new					
erosion.

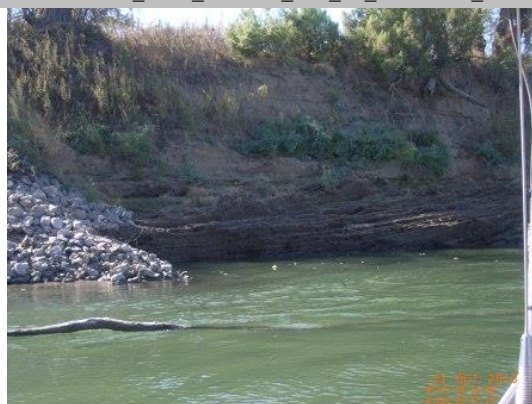
Photo 1 of 1 : FA_2019_NA0016_435_91_20190829_00029.jpg

LM Start	29.96	Rating **	A/W	Issue No.	91
LM End	30.12	Issue Type +	Ma	Location *	WS
Category	Supplemental			GPS Latitude/Longitude	
				Start	End
Item	2017 USACE Erosion Survey			39.065886 °	39.067386 °
				-121.842950 °	-121.845266 °
DWR ID	DWR_NA0016_01_f _ 2018_91

Comment Code					
Inspector Comment					
2017 Site ID: SAC 122.3 R					
Status: Eroding					
2017 Field Notes: Fresh slumping erosion at toe.					
Site History: 2002 - Upstream end has recent slope failure and exposure of tree roots. 2003 - Some new minor slope erosion with new snags on the bank. 2004 - Appears a little worse. 2005 - Scallop in bank at the upstream end looks worse. 2009 - Minimal new erosion, Berm width is still large, but one large event or one fallen tree and it could go fast. 2010 - New erosion, bank is nearly all vertical from slumping. Site looks bad. 2011 - Site continues to look bad. 2012 - Minor new erosion. 2015 - Undermining of toe rock. 2016 - Site extended upstream, new erosion and exposed tree roots.

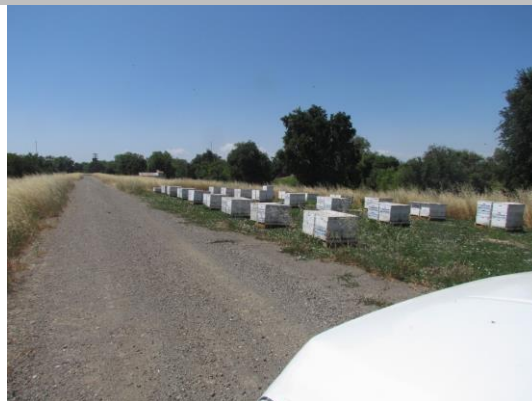
Photo 1 of 1 : FA_2019_NA0016_435_99_20190829_00036.jpg

LM Start	31.28	Rating **	M	Issue No.	99
LM End	31.28	Issue Type +	En	Location *	WS
Category	Earthen Levee			GPS Latitude/Longitude	
				Start	End
Item	Encroachments			39.066921 °	39.066921 °
				-121.864077 °	-121.864077 °
DWR ID	DWR_NA0016_01_s_2015_99				
Comment Code					
EQ : Equipment					
Inspector Comment					
Temporary bee hives are located on the waterside shoulder.

View of the beehives on the shoulder of the waterward side of the levee looking upstream. Spring 2015.

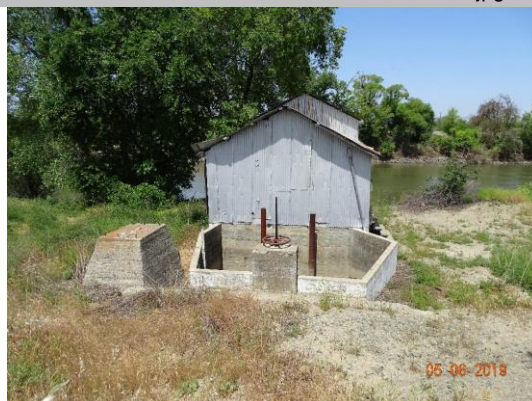
Photo 1 of 3 : UCIP_FA_2019_54143_79707.jpg

Comment Code						
Inspector Comment						
DS_ID:20261 FS_ID:54143 EP_NO: 9358 Repair Type: Non-Urgent Crossing Status: Found UCIP Comments: 05/06/2019 Pipe is running, no leaks observed. (O.Yakimov - DWR UCIP) FIELD_STRUCT_DESC: 3-foot by 3-foot reinforced concrete box irrigation culvert through the levee, 18 feet below the crown. Slide gate on the waterside (WS) inside a concrete surge box. Pump house on the WS berm. 5-foot by 7-foot concrete distribution box at the landside (LS) toe. Overhead power line crosses the levee. Pole on the WS shoulder (3-foot by 3-foot culvert [HLM 31.78] Automatic Board Order (ABO) issued as Permit No. 9358, 1974 - Crocker National Bank (Trustee)). [Additional Reference(s): USACE Sacramento O&M Manual 131, May 1960 (HLM 31.78)]. FS Date: 5/6/2019 3:43:23 PM

Pump house on WS

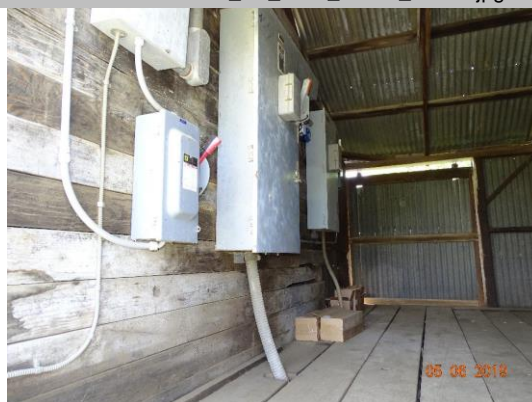
Photo 2 of 3 : UCIP_FA_2019_54143_79709.jpg

View inside of pumphouse

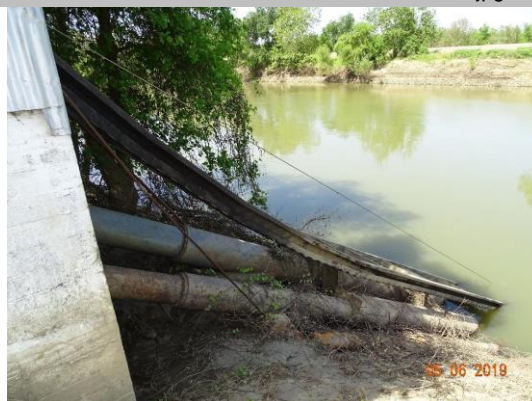
Photo 3 of 3 : UCIP_FA_2019_54143_79710.jpg

Pipes at river's edge

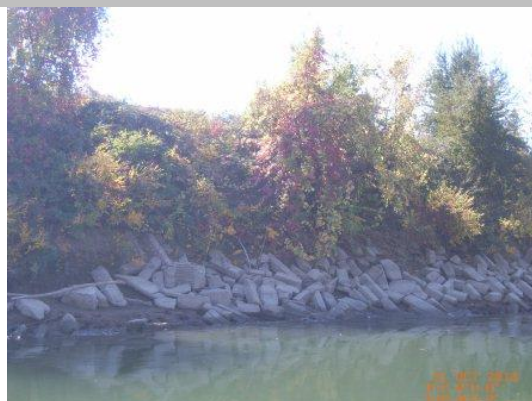
Photo 1 of 1 : FA_2019_NA0016_435_92_20190829_00030.jpg

LM Start	31.43	Rating **	A/W	Issue No.	92
LM End	31.45	Issue Type +	Ma	Location *	WS
Category	Supplemental			GPS Latitude/Longitude	
				Start	End
Item	2017 USACE Erosion Survey			39.067004 °	39.066901 °
				-121.866913 °	-121.867322 °
DWR ID	DWR_NA0016_01_f_2018_92				
Comment Code					
Inspector Comment					
2017 Site ID: SAC 123.7 R					
Status: Eroding					
2017 Field Notes: No observed change.					
Site History: 1997 - Erosion into the levee section; old concrete rubble loss at toe; transition between the rock upstream and the cobble downstream. 2000 - Cohesive bench with concrete slabs on top; 25 ft deep scour hole on the downstream end.

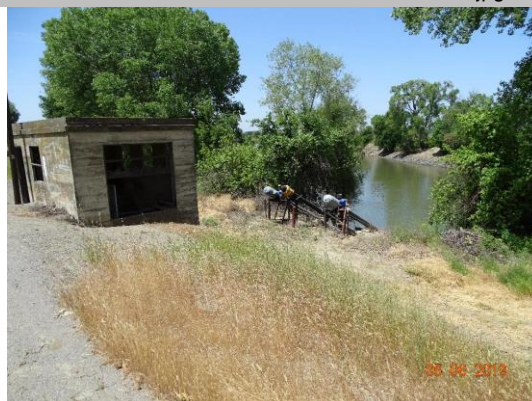
Photo 1 of 3 : UCIP_FA_2019_54144_79713.jpg

UCIP Comments: 05/06/2019 Power line for this group of pumps that has been run underground to service box on WS shoulder at LM 31.63 should be recorded as a separate crossing. (O.Yakimov - DWR UCIP) 03/15/2013 Pipe leaking at intake pipe on rivers edge below pump FIELD_STRUCT_DESC: 24-inch steel irrigation pipe through the levee, 24 feet below the crown. Slide gate in abandoned concrete pump house on the waterside (WS) slope. Three slant pumps mounted on a pile structure on the WS bank. 30-inch concrete pipe under the highway on the landside (LS). 48-inch steel riser unit on the LS of the highway. Overhead high tower power line crosses the levee. Power line has been run underground to service box on WS shoulder at LM 31.63. Ramps on both slopes. (Automatic Board Order (ABO) issued as Permit No. 9338, 1974 - Julie Ann Steidlmaier). [Additional Reference(s): DWR Levee Log, 2006. USACE Sacramento O&M Manual 131, May 1960 (HLM 32.02)].

Concrete block house with slide gateinside

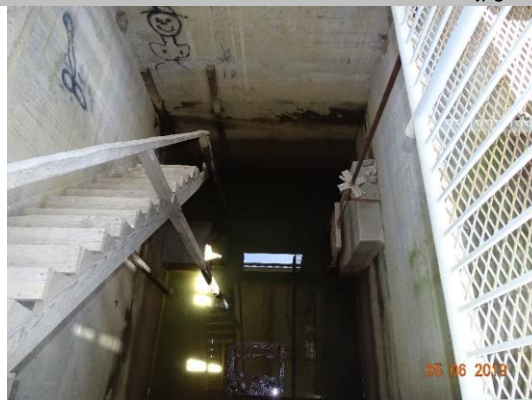
Photo 2 of 3 : UCIP_FA_2019_54144_79714.jpg

Slide gate inside concrete blockhouse

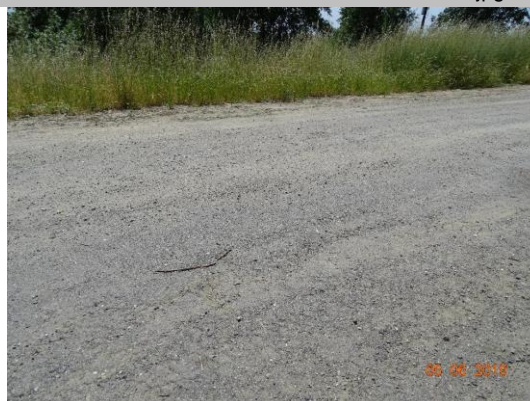
Photo 3 of 3 : UCIP_FA_2019_54144_79719.jpg

Levee crown at crossing

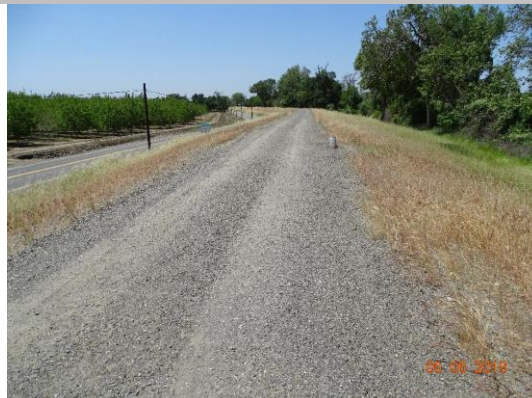
Photo 1 of 3 : UCIP_FA_2019_54146_79725.jpg

Comment Code						
Inspector Comment						
DS_ID:20263 FS_ID:54146 EP_NO: 1755A Repair Type: Non-Urgent Crossing Status: Found UCIP Comments: 05/06/2019 Steel riser on WS berm is damaged. Portion of pipe is visible on LS slope. It gets impacted every time vegetation control is performed. (Special condition twenty of permit 1755-A hasn't been met. Pipe needs to be buried at least 12 inches in the levee slope.) (O.Yakimov - DWR UCIP) FIELD_STRUCT_DESC: 18-inch steel irrigation pipe through the levee, 4 feet below the crown. Slant pump on the waterside (WS) bank. Siphon breaker inside a 12-inch steel riser unit on the WS shoulder. Pipe may terminate inside an 18-inch concrete riser on the landside (LS) toe. (Permit No. 1755-A, 1979 - Julie Ann Steidlmayer). (Replaced 18-inch steel pipe installed under Permit No. 1755, 1953 - Pete Andreotti). [Additional Reference(s): DWR Levee Log, 2006]. FS Date: 5/6/2019 8:27:11 AM

Levee crown at crossing. Damaged steel riser on WS shoulder

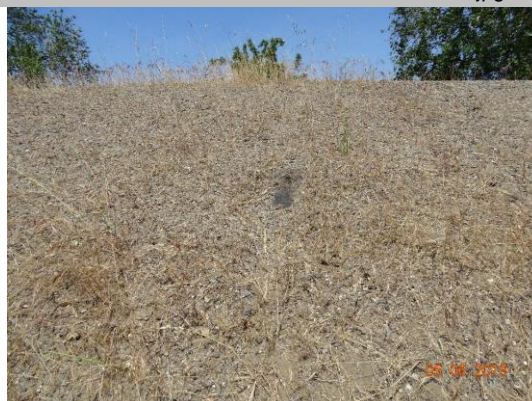
Photo 3 of 3 : UCIP_FA_2019_54146_79727.jpg

View of LS slope

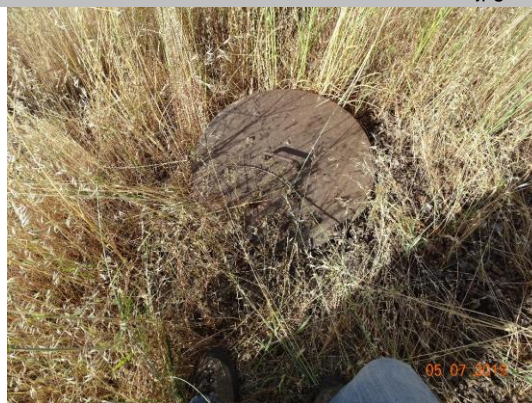
Photo 1 of 3 : UCIP_FA_2019_54148_79730.jpg

Comment Code						
Inspector Comment						
DS_ID:20304 FS_ID:54148 EP_NO: 9374 Repair Type: Non-Urgent Crossing Status: Indicator Found UCIP Comments: 05/06/2019 Crossing looks abandoned, so needs a proper abandonment or removal. (DWR UCIP O.Yakimov)03/15/2013 Need to verify type of abandonment FIELD_STRUCT_DESC: *ABANDONED* 2 of 4: 4-inch irrigation pipe of an unknown material through the levee, 6.5 feet below the crown. Gate valve on the waterside (WS) end. Siphon breaker inside a 24-inch corrugated metal riser unit on the landside (LS) slope. 4-foot by 4-foot concrete distribution box on the south side of Highway 45 at the LS toe. (Automatic Board Order (ABO) issued as Permit No. 9374, 1974 - Richard H. Moore). [Additional Reference(s): DWR Levee Log, 1980. USACE Sacramento O&M Manual 131, May 1960 (HLM 32.68)]. FS Date: 5/6/2019 1:42:33 PM

CMP riser on LS slope

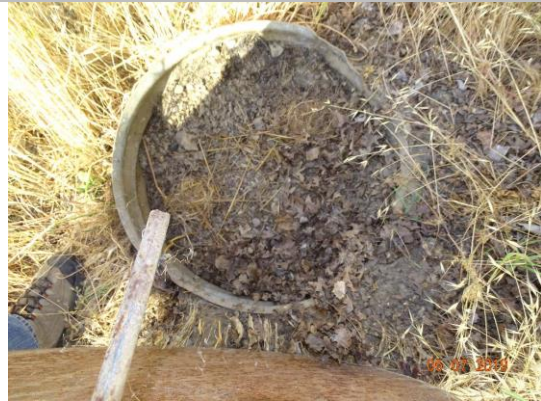
Photo 2 of 3 : UCIP_FA_2019_54148_79731.jpg

Riser is filled with soil

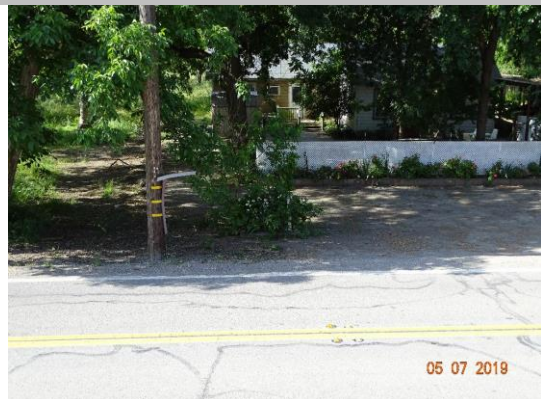
Photo 3 of 3 : UCIP_FA_2019_54148_79732.jpg

LS berm where 4x4 concrete box is located

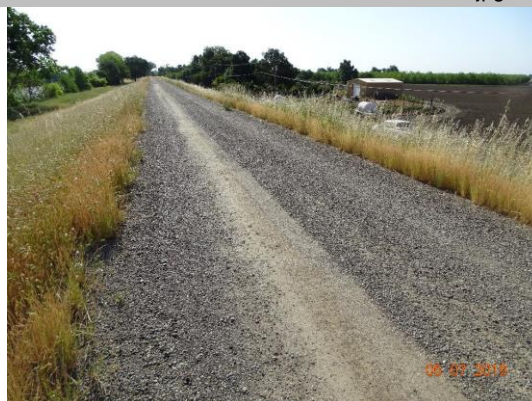
Photo 1 of 3 : UCIP_FA_2019_54149_79734.jpg

Comment Code					
Inspector Comment					
DS_ID:20264 FS_ID:54149 EP_NO: 9339 Repair Type: Non-Urgent Crossing Status: Found UCIP Comments: 05/07/2019 Electric motor is taken off its platform at slant pump on WS berm. Bare wires coming off a conduit near electric box on WS berm. Concrete standpipe is broken at ground level near distribution box on LS that poses fall hazard to the crossing. (O.Yakimov - DWR UCIP) FIELD_STRUCT_DESC: 24-inch corrugated metal irrigation pipe through the levee, 21 feet below the crown. Slide gate inside a concrete box on the waterside (WS) berm. Slant pump on the WS bank. Pipe discharges into a 7-foot by 9-foot concrete box across the county road. Service pole and switch panel on the WS berm. (Automatic Board Order (ABO) issued as Permit No. 9339, 1974 - Allen Moore). [Additional Reference(s): DWR Levee Log, 2006. USACE Sacramento O&M Manual 131, May 1960 (HLM 32.87)]. FS Date: 5/7/2019 2:32:26 PM

Levee crown at crossing

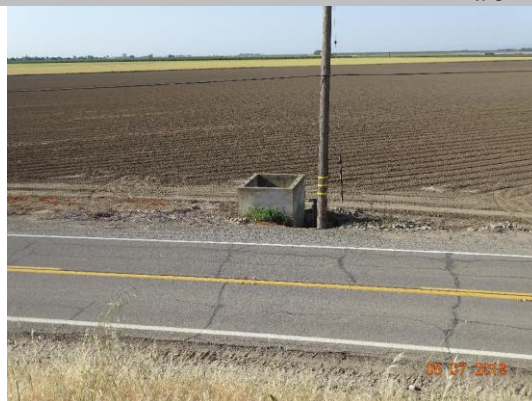
Photo 2 of 3 : UCIP_FA_2019_54149_79735.jpg

7X9-foot concrete distribution boxoff LS toe

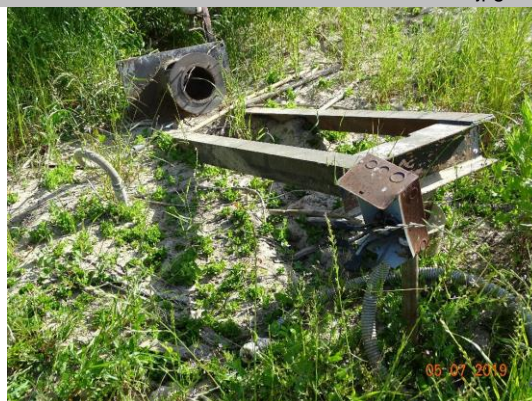
Photo 3 of 3 : UCIP_FA_2019_54149_79736.jpg

Slant pump on WS berm without motor

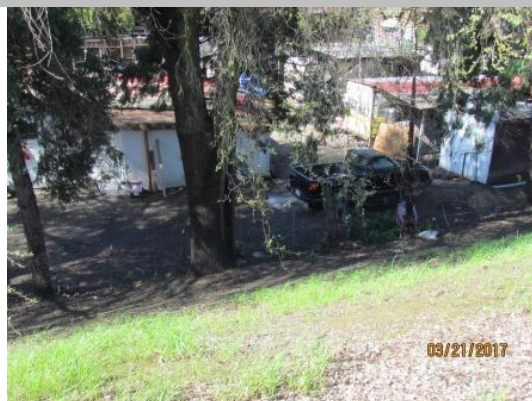
Photo 1 of 1 : FA_2019_NA0016_435_43_20190829_00015.jpg

LM Start	32.97	Rating **	M	Issue No.	43
LM End	32.97	Issue Type +	En	Location *	LS
Category	Earthen Levee			GPS Latitude/Longitude	
				Start	End
Item	Encroachments			39.074346 °	39.074346 °
				-121.892048 °	-121.892048 °
DWR ID	DWR_NA0016_01_s_2019_43				
Comment Code					
FE : Fence					
Inspector Comment					
Fence is blocking access on the landside toe.

View of fence along landside levee toe. Spring 2017.

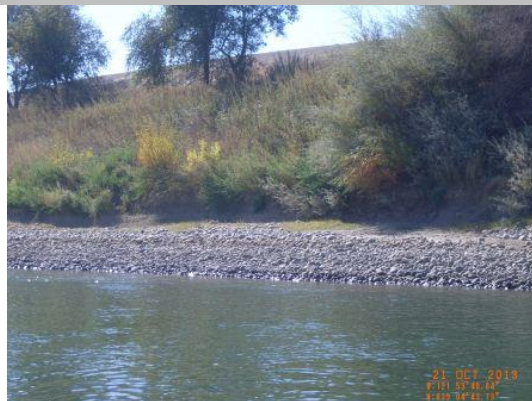
Photo 1 of 1 : FA_2019_NA0016_435_93_20190829_00031.jpg

LM Start	33.29	Rating **	A/W	Issue No.	93
LM End	33.37	Issue Type +	Ma	Location *	WS
Category	Supplemental			GPS Latitude/Longitude	
				Start	End
Item	2017 USACE Erosion Survey			39.078340 °	39.079351 °
				-121.894656 °	-121.895317 °
DWR ID	DWR_NA0016_01_f_2018_93				
Comment Code					
Inspector Comment					
2017 Site ID: SAC 125.6 R					
Status: Eroding					
2017 Field Notes: No observed change.					
Site History: 2008 - Slow erosion of the hard toe. 2010 - Cobble rubble is failing, erosion is into the toe of the levee, with vertical slumping.					
2012 - Site appears to be relatively stable. 2013 - New animal holes.

USACE 2013 Photo #1

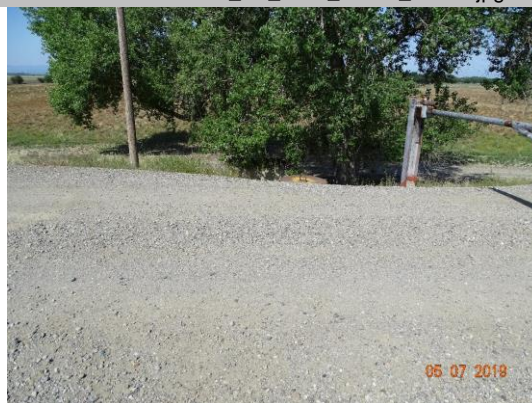
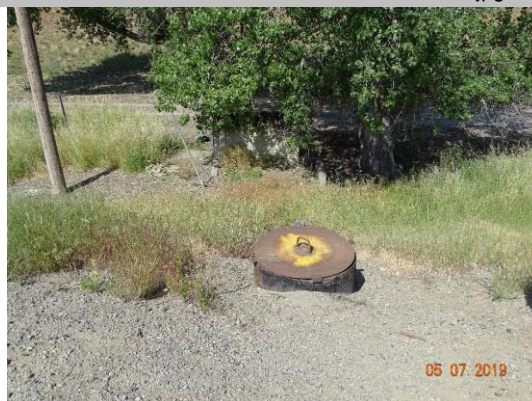
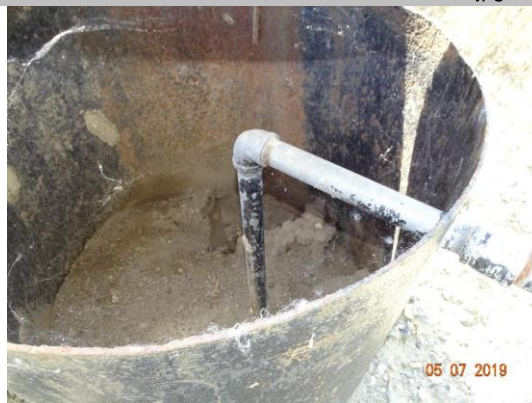
Comment Code						
Inspector Comment						
DS_ID:20268 FS_ID:54156 EP_NO: 9364A Repair Type: Non-Urgent Crossing Status: Found UCIP Comments: 05/07/2019 This pipe is a candidate for internal video inspection. (O.Yakimov - DWR UCIP)03/18/2013 Pipe rusted through at concrete distribution box. May be indicator of pipe condition through levee. FIELD_STRUCT_DESC: 1 of 4: 16-inch steel irrigation pipe through the levee, 6.3 feet below the crown. Pump in pump house on the waterside (WS) end. Siphon breaker in a 36-inch steel riser unit on the landside (LS) slope. Discharges into a 5-foot by 9-foot concrete distribution box at the LS toe. (Automatic Board Order (ABO) issued as Permit No. 9364-A, 1974 - Alice Steidlmayer). (Installed by the United States Army Corp of Engineers, 1945). [Additional Reference(s): DWR Levee Log, 2006. USACE Sacramento O&M Manual 131, May 1960 (HLM 34.46)]. FS Date: 5/7/2019 8:34:43 AM

Levee crown at crossing

Air vent in 36-inch steel riser on LS shoulder

Air vent comes out of steel riser

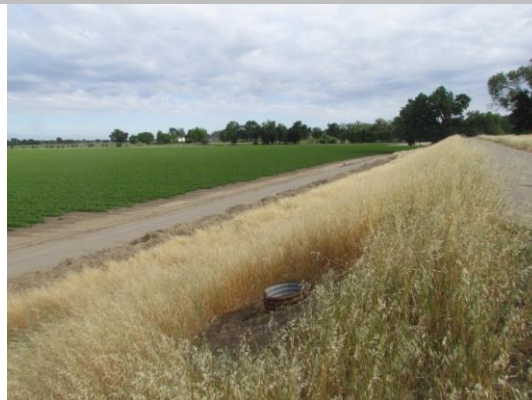
Photo 1 of 1 : FA_2019_NA0016_435_100_20190829_00037.jpg

LM Start	34.01	Rating **	M	Issue No.	100
LM End	34.07	Issue Type +	En	Location *	LS
Category	Earthen Levee			GPS Latitude/Longitude	
				Start	End
Item	Encroachments			39.087176 °	39.088099 °
				-121.896480 °	-121.896498 °
DWR ID	DWR_NA0016_01_f_2018_100				
Comment Code					
DT : Ditch					
Inspector Comment

View of the ditch at the landward side of the levee looking upstream. Spring 2015.

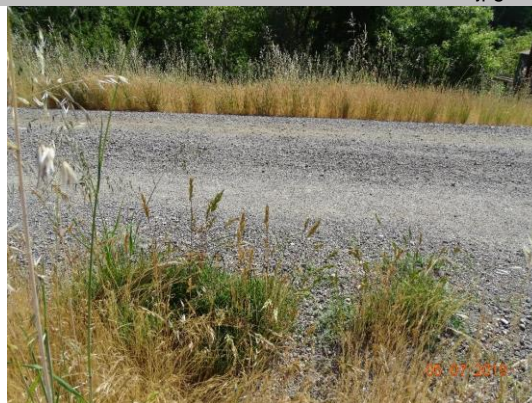
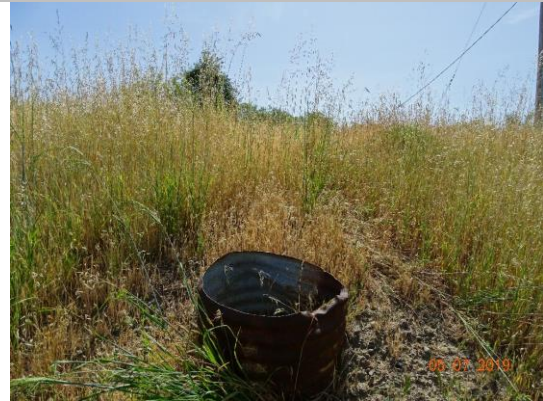
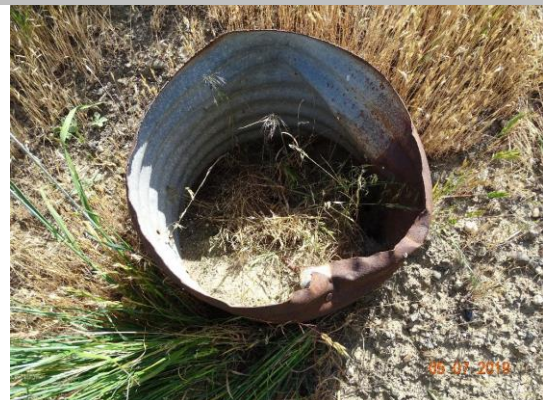
Comment Code					
Inspector Comment					
DS_ID:20269 FS_ID:54157 EP_NO: 9364A Repair Type: Non-Urgent Crossing Status: Indicator Found UCIP Comments: 05/07/2019 Abandoned crossing. Needs to be properly abandoned or removed. (O.Yakimov - DWR UCIP) FIELD_STRUCT_DESC: *ABANDONED* 2 of 4: 16-inch steel irrigation pipe through the levee, 6.5 feet below the crown. Plugged on the waterside (WS) end. Siphon breaker in a 24-inch corrugated metal riser unit on the landside (LS) shoulder (Automatic Board Order (ABO) issued as Permit No. 9364-A, 1974 - Alice Steidlmayer). [Additional Reference(s): DWR Levee Log, 2006. USACE Sacramento O&M Manual 131, May 1960 (HLM 34.47)]. FS Date: 5/7/2019 11:18:46 AM

Levee crown at crossing

24-inch CMP riser on LS shoulder

View inside of CMP riser

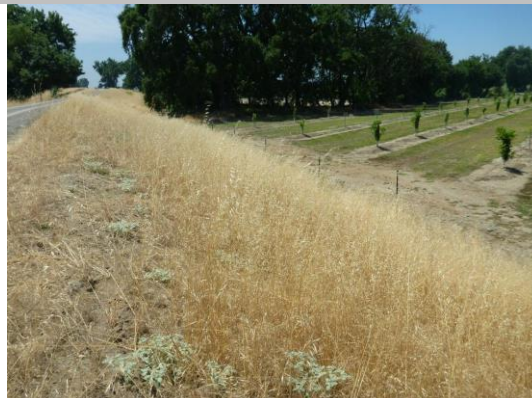
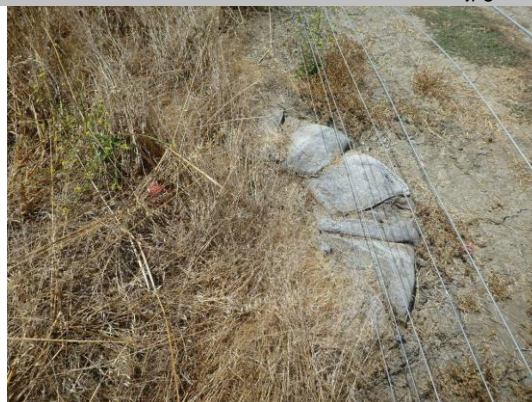
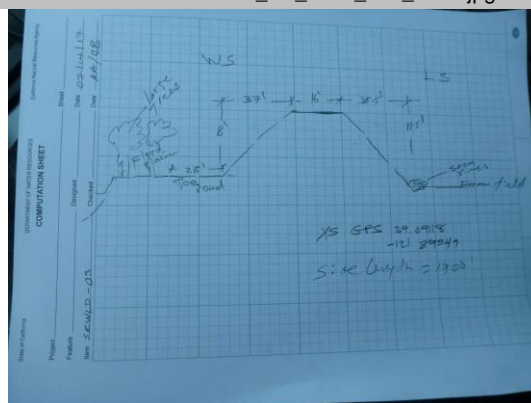
LM Start	34.24	Rating **	A/W	Issue No.	123
LM End	34.56	Issue Type +	Ob	Location *	
Category	Supplemental			GPS Latitude/Longitude	
				Start	End
Item	2017 Storm Damage			39.090511 °	39.094967 °
				-121.895675 °	-121.894858 °
DWR ID	SRWLD-03				
Comment Code					
Inspector Comment					
Levee Evaluation Comments					
Description:					
Site ID No:185					
Site Designation:SRWLD-03					
Repair Type: Seepage					
Rating:Critical					
Field Date:7/14/2017					
Notes: Well water tank 10' from LS toe & wire fence at LS toe					
Potential seepage berm site.

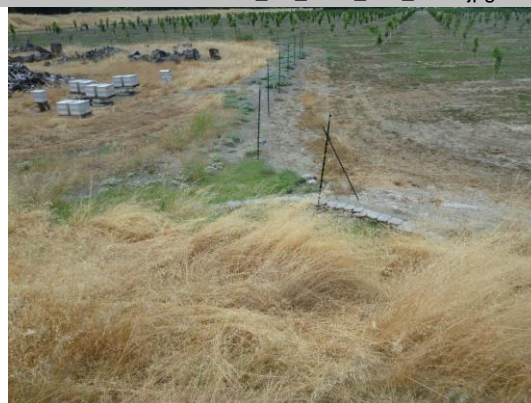
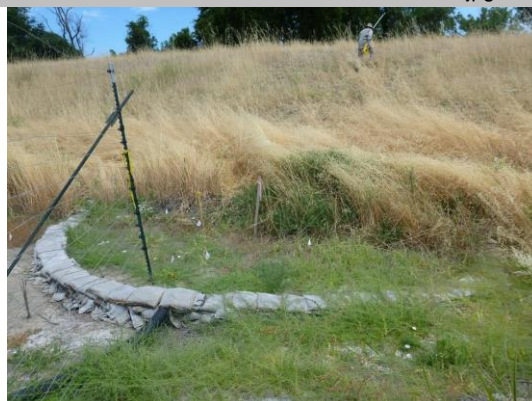
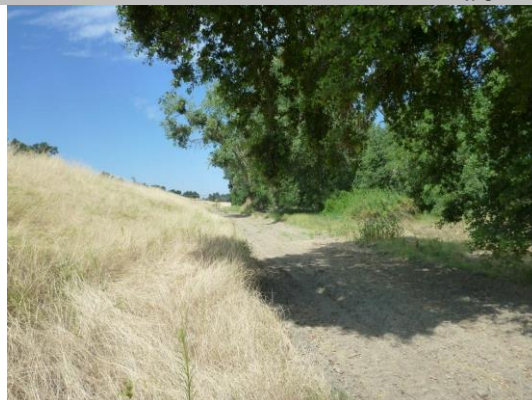
LM Start	34.65	Rating **	A/W	Issue No.	125
LM End	34.72	Issue Type +	Ob	Location *	
Category	Supplemental			GPS Latitude/Longitude	
				Start	End
Item	2017 Storm Damage			39.095592 °	39.095589 °
				-121.896103 °	-121.897400 °
DWR ID	SRWLD-02				
Comment Code					
Inspector Comment					
Levee Evaluation Comments Description: Site ID No:184 Site Designation:SRWLD-02 Repair Type: Seepage Rating:Critical Field Date:7/14/2017 Notes: Potential seepage berm site.

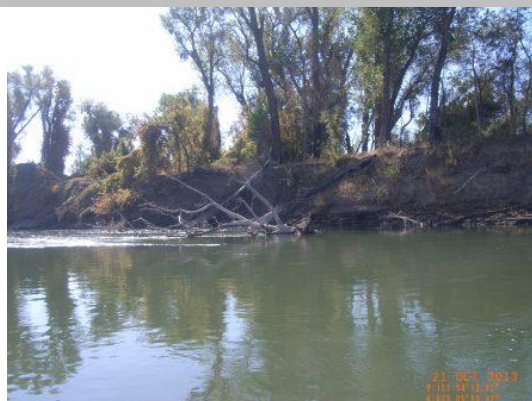
Photo 1 of 1 : FA_2019_NA0016_435_94_20190829_00032.jpg

2017 Site ID: SAC 127.9 R
Status: Eroding
2017 Field Notes: fresh erosion at lower slope.
Site History: 1997 - Major scour off the downstream end of existing rock, creating a scour pocket where the levee starts diverging from the bankline. 2000 - Some minor erosion, 20 ft deep hole at downstream end. 2004 - Small amount of new erosion. 2010 - Bad transition off downstream end of rock revetment, some new erosion. 2012 - Site extended downstream, minor new erosion. 2013- Minor new erosion. 2016 - Fresh erosion at toe.

USACE 2013 Photo #1

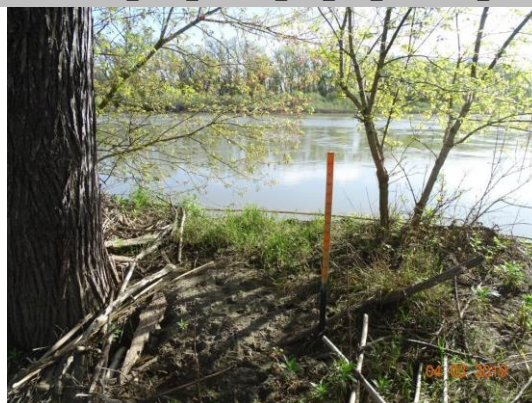
Photo 1 of 5 : FA_2019_NA0016_435_114_20190829_00048.jpg

Erosion on the waterside berm reported during 2018 storms. Approximately 45' from the bank to the waterside toe is left. Recommend monitoring.

View of the downstream stake on the waterside berm. Spring 2019.

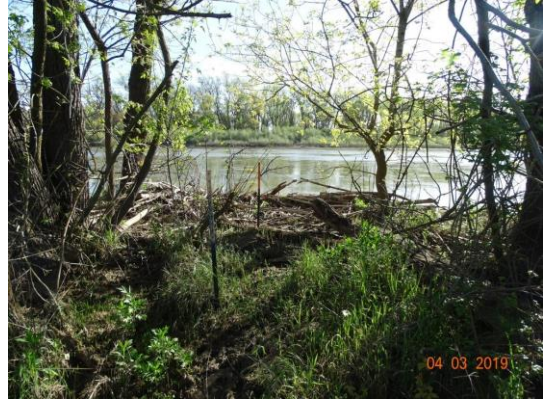
Photo 2 of 5 : FA_2019_NA0016_435_114_20190829_00049.jpg

View of the middle stake on the waterside berm. Spring 2019.

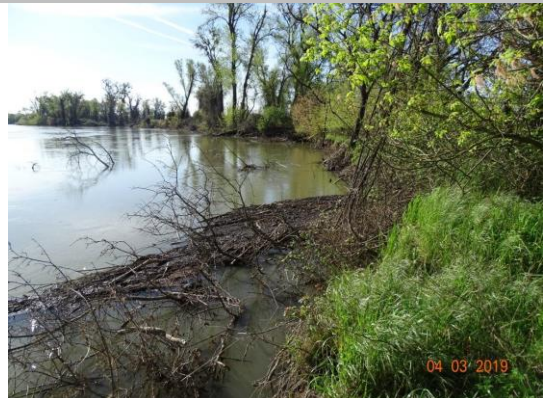
Photo 3 of 5 : FA_2019_NA0016_435_114_20190829_00050.jpg

View of the erosion site facing downstream. Spring 2019.

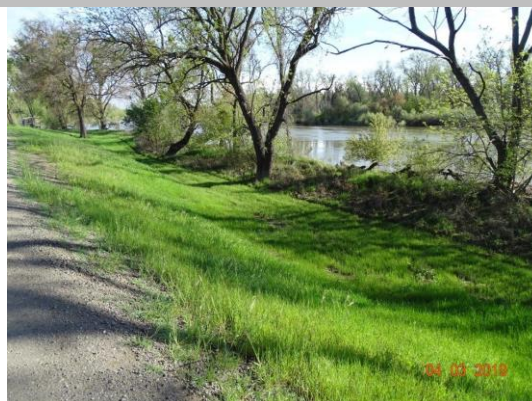
Photo 5 of 5 : FA_2019_NA0016_435_114_20190829_00052.jpg

View of the erosion site from the crown, facing upstream. Spring 2019.

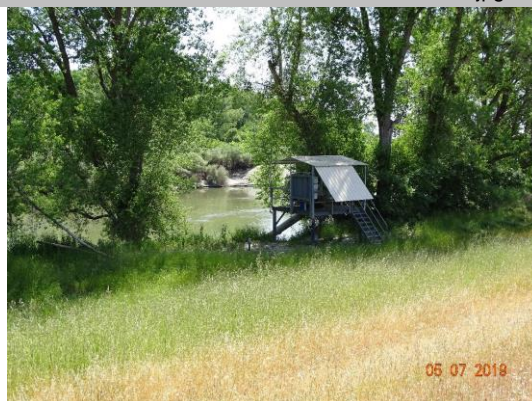
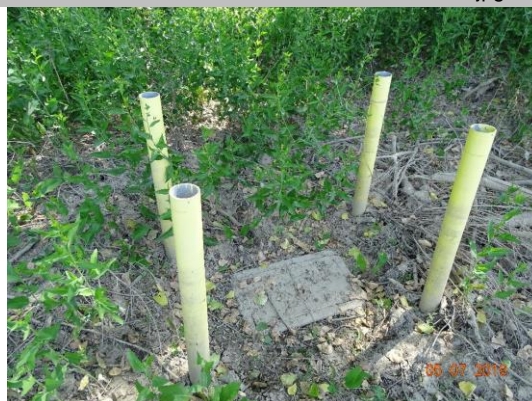
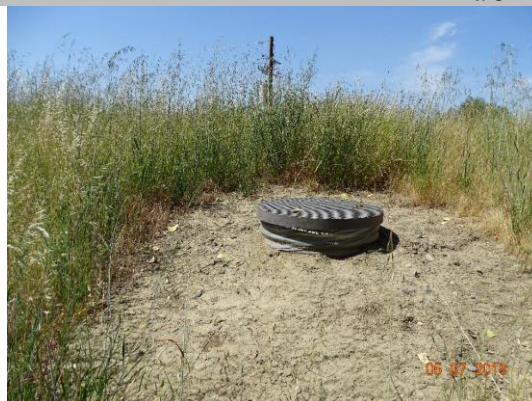
Comment Code					
Inspector Comment					
DS_ID:20306 FS_ID:54161 EP_NO: 12632 Repair Type: Non-Urgent Crossing Status: Found UCIP Comments: 05/07/2019 Crossing is excavated on LS berm for installation of 2 discharge pipes with butterfly valves. A shutoff device installed before crossing enters CMP standpipe near LS toe. (O.Yakimov - DWR UCIP) FIELD_STRUCT_DESC: 18-inch steel irrigation pipe through the levee, 6 feet below the crown. Pump and motor on pile platform on the waterside (WS) approximately 300 feet downstream from the pipe crossing, an ait vent next to it. Butterfly valve in covered corrugated metal riser on WS shoulder, utility box at WS toe. Siphon breaker inside a 12-inch corrugated metal riser unit on the landside (LS) shoulder. 55-inch corrugated metal standpipe near the LS toe. (Permit No. 12632, 1979 - J. Peter Steidlmayer, Secondary Permit No. 12632-A, 2011 - J. Peter Steidlmayer). [Additional Reference(s): DWR Levee Log, 1980]. FS Date: 5/7/2019 1:02:00 PM

Pumping platform and air vent on WS berm

Utility box at estimated location of pipe connection

CMP riser at WS shoulder

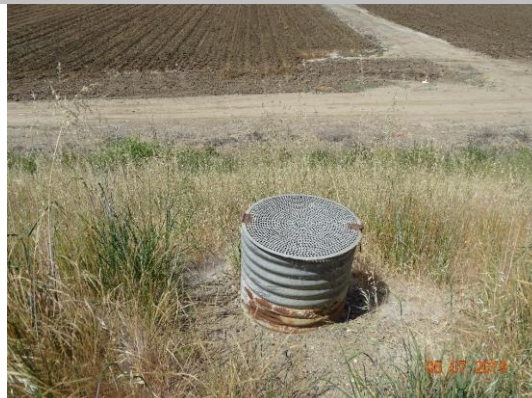
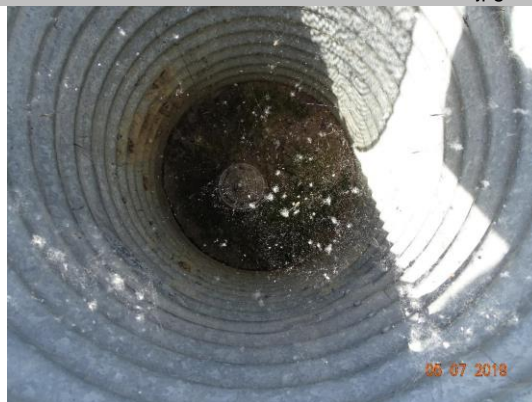
Comment Code						
Inspector Comment						
DS_ID:20273 FS_ID:54162 EP_NO: 9364A Repair Type: Non-Urgent Crossing Status: Indicator Found UCIP Comments: 05/07/2019 Crossing looks abandoned. Should be removed or abandoned properly. (O.Yakimov - DWR UCIP)03/18/2013 Need to verify type of abandonment. FIELD_STRUCT_DESC: 3 of 4: 18-inch steel irrigation pipe through the levee, 16 feet below the crown. Metal cutoff wall. Gate valve on the waterside (WS) bank. Siphon breaker in a 24-inch corrugated metal riser unit on the landside (LS) shoulder. (Automatic Board Order (ABO) issued as Permit No. 9364-A, 1974 - Alice Steidlmayer). [Additional Reference(s): DWR Levee Log, 2006. USACE Sacramento O&M Manual 131, May 1960 (HLM 36.04)]. FS Date: 5/7/2019 3:05:52 PM

Siphon breaker in 24-inch CMP riser on LS shoulder

View inside of CMP riser
